## Spill Prevention Control and Countermeasure Inspection Findings, Alleged Violations, and Proposed Penalty Form

## SPCC - EXPEDITED FIELD ENFORCEMENT PROGRAM

SITE NAME: N all/Longview SPCC TDD#: S06-9802-008 PHOTO#: 104 dOTOGRAPHER/WITNESS: Green/Hood

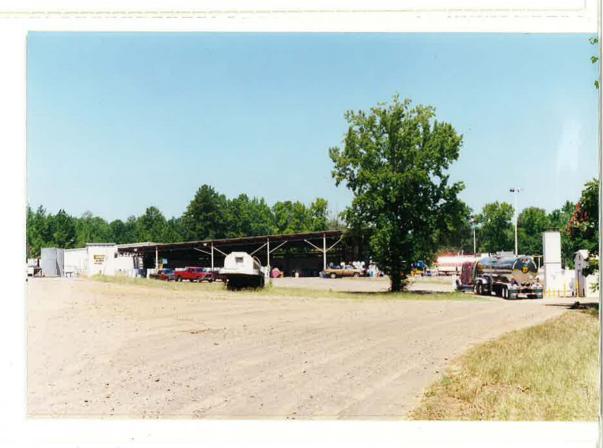
SITE NAME: SPCC Recon for Gregg Co. TDD#:\S06-9\u00e9\u00e9-008 PHOTO#: 107 PHOTOGRAPHER/WITNESS: Wakefield/Green

DATE: 07/29/98 TIME: 1213 DIRECTION:-W
Overview of Cook Composites and Polymers

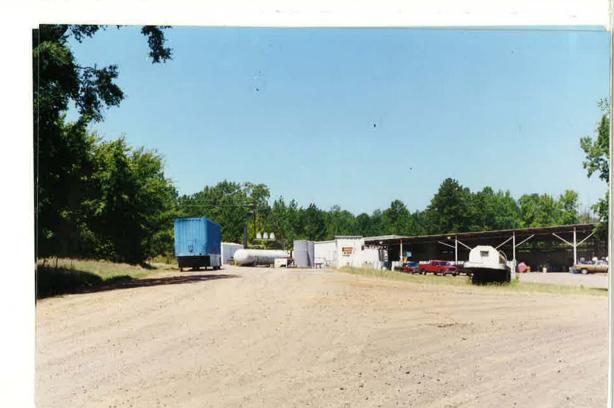
SITE NAME: SPCC Recon for Gregg Co. TDD#: S06-9802-008 PHOTO#: 108-PHOTOGRAPHER WITNESS: Wakefield/Green DATE: 07/29/98 TIME: 1213 DIRECTION: W

Overview of Cook Composites and Polymers

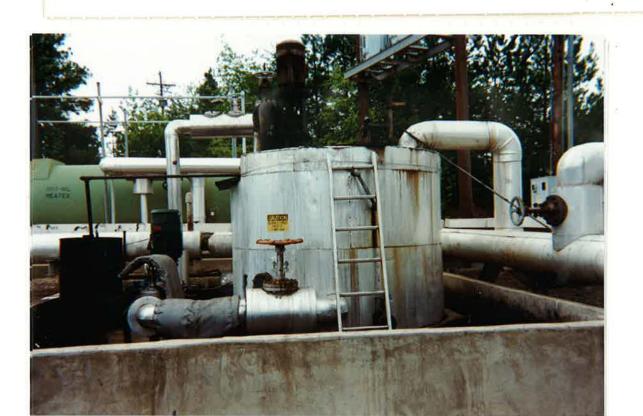
SITE N :: Marshall/Longview SPCC TDD#: S06-9802-000 PHOTO#: 106 PHOTOGRAPHER/WITNESS: Green/Hood

overview of heat transfer tank
